**International Forestry**  
**CONSULTANTS, INC.**

**TREE PLAN FOR WOODY SHORT PLAT**  
**12420 NE 70<sup>TH</sup> COURT**  
**KIRKLAND, WA**

**PARCEL #1241500022**

**JUNE 1, 2007**

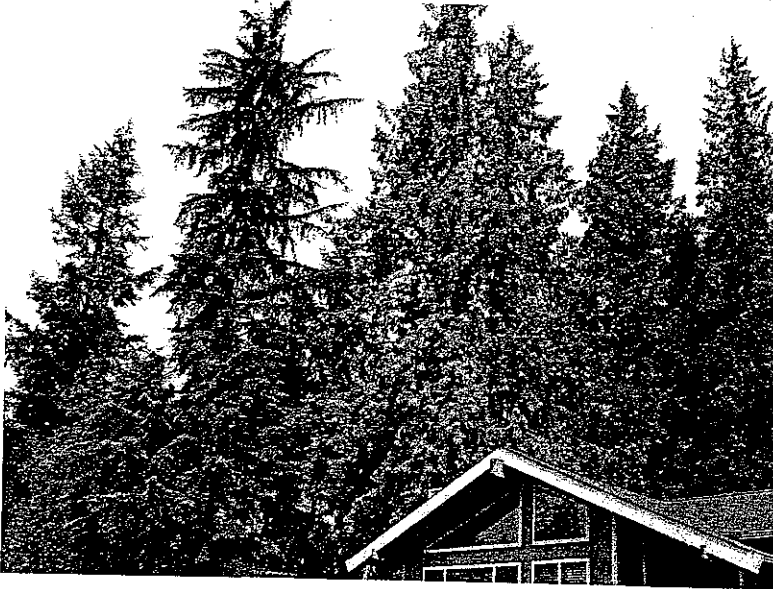
Tree #12 is a mature western hemlock. This tree has developed an unnatural lean to the northwest. Structural stability may have been compromised during the December 14<sup>th</sup> windstorm. The main trunk forks into codominant stems at 36' above ground. These stems appear to protrude from the main trunk via a narrow angle of attachment. The foliage is of fair density and good color. This tree would not be a good candidate for retention through the development of this lot, due to cumulative structural defects and a moderate to high potential for failure.

Forked top of Tree #12
